## HOW DEMOLITION CAN BE KEY TO THE SUCCESS OF YOUR LEED PROJECT

Casey Middle School - Boulder, Colorado

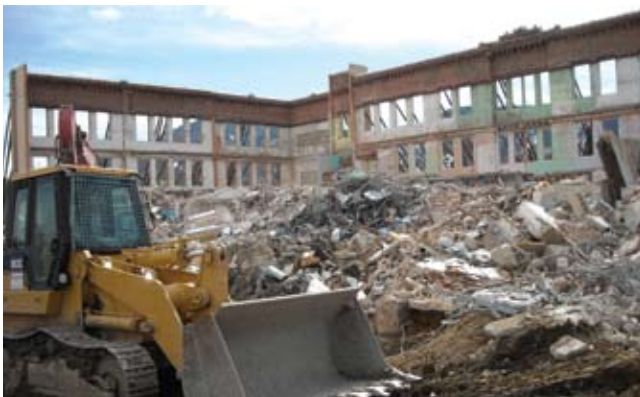
**PHASING & OBSTACLES:** After removing the Library addition, and entry corridor, Hillen Corp. discovered that a main bearing wall had previously been removed and resupported with cantilevered steel beams that in turn supported the third floor and bearing walls. This also exposed the front facade and boiler room in the basement buried under the entry sidewalk. If removal had gone according to original plans it would have undermined the original facade from being saved. In order to allow the general contractor (Saunders Construction) to provide shoring and wall bracing, Hillen Corp. needed to also expose interior structural walls so that through-bolt connections could be made to interior structural steel.

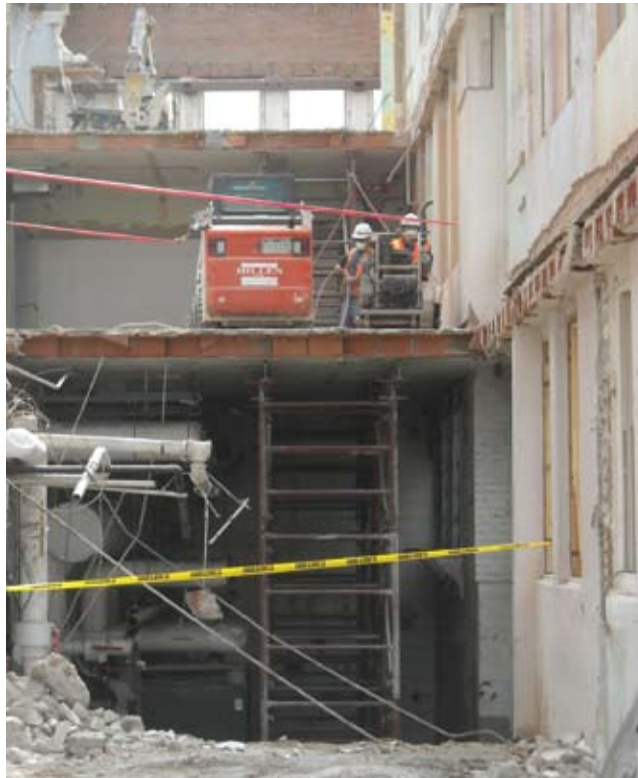
The remaining additions were systematically removed to not affect the stability or the front facade and maintain the schedule. After the new wall bracing was in place, wood roof and ceiling joists were removed. Hillen Corp. then began separating the exterior walls to be saved. Retaining these key portions of the existing structure provide credits in the LEED certification process.

With the use of electric-powered remote-control hydraulic excavators, Hillen Corp. is able to increase not only its production, but efficiency and the high priority of safety necessary in large projects. This technology allows access to areas perhaps too dangerous for Hillen's crews. By using a combination of these electric excavators along with skid steer loaders, the cast in place concrete and tile floor systems, the second and third floors were removed. After removing one grid line of the structure away from the remaining facade, the demolition crew used a CAT 330 ultra-high reach in combination with a KOMATSU 400 with grapple and universal processor to demolish the remainder of the building.
